**AN INVESTIGATION OF THE EARLY
19th CENTURY PLATEWAY TRAMWAY
USED AT THE IRON ORE AND COAL
PATCHES BETWEEN WISEMANS
BRIDGE AND AMROTH.**

**GARY P.T. DAVIES HND ABC
2007-2008**

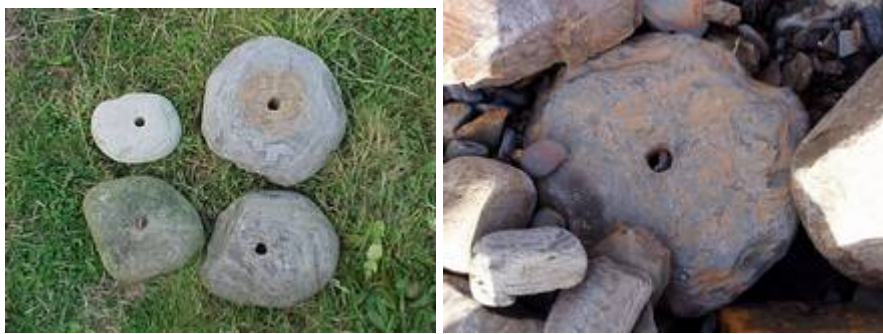
Stone sleepers from the beach at Crickdam and Burrows patches.

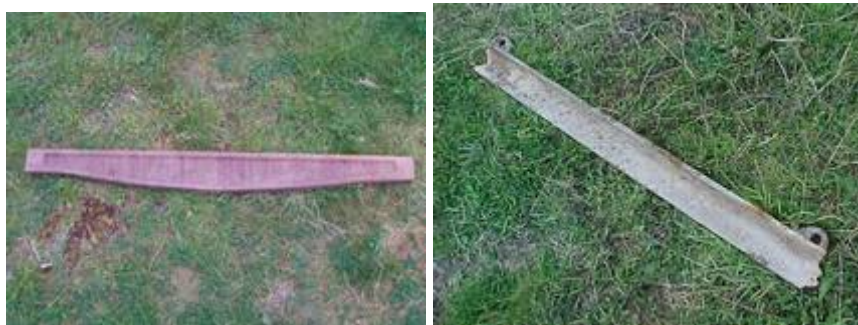
Early Saundersfoot Railway fish belly track on the left and Plateway track on the right.

I set about trying to find out how the Plateway was fitted to the stone sleepers and found that when two pieces of Plateway were offered up end-to-end they needed a sleeper with two holes in to keep the ends from coming apart.

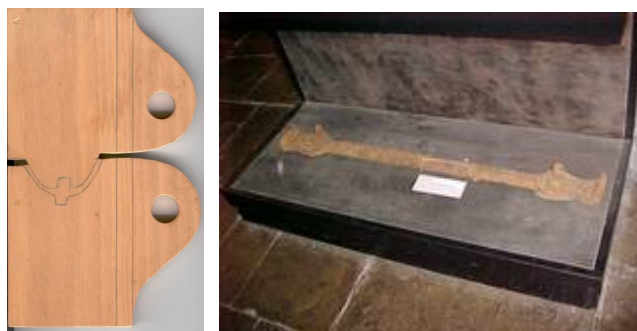
Left is a wooden template of the ends of Plateway and right a sleeper on display at Cyfarthfa Castle.

One day in 1997 I was with my father on a day trip to Cyfarthfa Castle, Merthyr and in one of the displays of the Crawshays Iron Masters I discovered a cast iron sleeper that was meant to fix the Plateway in position. I knew then this is what I had to find on the “patches”.

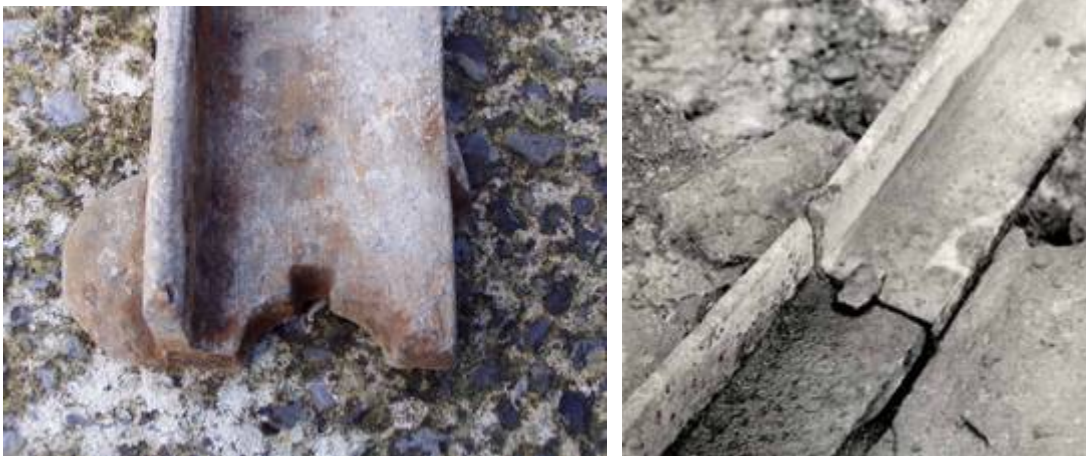
Found at the Grove Colliery the Plateway on the left was fixed to the sleeper by a single pin driven into the slot when they were placed end to end, as shown in the right hand picture.

During some building work at the back of Hill House, Amroth in 2004 a new size of Plateway was found. The Plateway I had found at Bridge “patch” was 3 ½ inches across; this new piece was 3 inches across. Another part of the puzzle. The larger 3 ½-inch Plateway had a rib underneath along its length to provide more strength to the L section but the smaller 3-inch size Plateway was flat along the bottom. Was the larger, strengthened Plateway a later modified version of the smaller one due to breakages under heavy loaded drams? Another different type of Plateway turned up during the conservation of the Grove Colliery buildings. This Plateway is the smaller 3-inch size and has flanges on one side of each end of the track but has no hole in the flanges like the Plateway found at the Bridge “patch” and Crickdam “patch”. The Plateway found at Grove is connected to a stone or wooden sleeper by a single pin driven through a slot in the ends. I have not found any evidence at the moment of this type of Plateway being used at the “patches” yet.

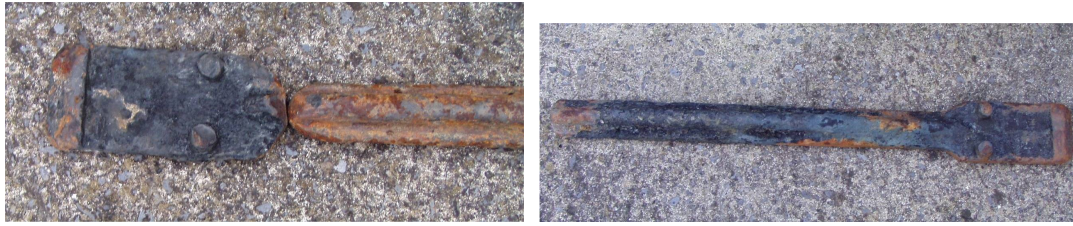
On the left are the two pieces of sleeper found on the Sunday and right the piece found the next Saturday.

I now had a few pieces of the puzzle but still needed to know how the Plateway was held in place. Then came the storms of January 2007. I went down on the Sunday after the first storm of the New Year and arriving at Crickdam was greeted by a scattering of metal fragments everywhere. I picked up screws, nails and pieces of wrought iron, then I picked up a large lump of iron and was confused as it looked like T section railway track, but a size I had not seen before. I put it on the top of a large stone and picked up a different shaped lump of metal. After looking at it for a couple of seconds I could see amongst the crust of many years of rust, a shape I thought I had seen somewhere before. Then it dawned on me I had found what I had been looking for during the last 9 years of searching the “patches”. I had found one end and a middle section of a cast iron sleeper similar to the one I had seen in Cafarthfa Castle in 1997. After getting it home and cleaning it up I found that it fitted the smaller 3-inch section of Plateway. I now needed to find a complete or near complete sleeper to give me the gauge of the Plateway.

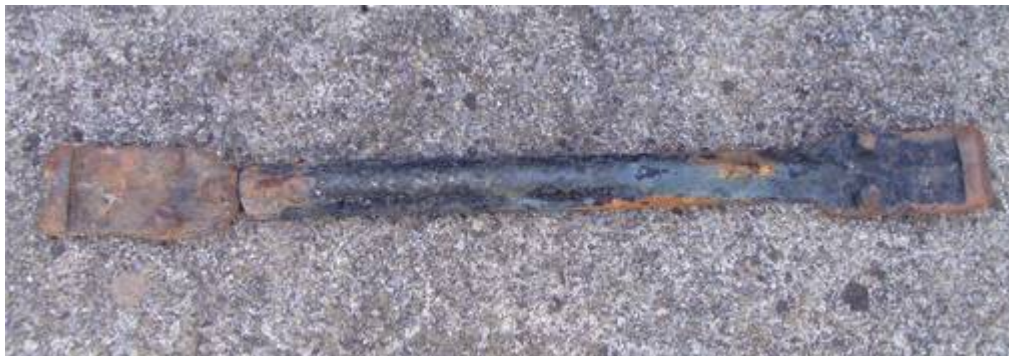
The complete cast iron sleeper.

On the 18th January a storm hit the UK with 100 mph winds. Saturday the 20th I went down to Crickdam with my metal detector and located more sections of both sizes of Plateway. On the rocks nearby was a length of crusted rusty metal, I went over to it and found to my delight this was a near complete sleeper. After getting it home and cleaning it up I found that the end piece I had found the weekend before mated up to it exactly. The gauge of the 3-inch Plateway is 2 ft 10 inches.

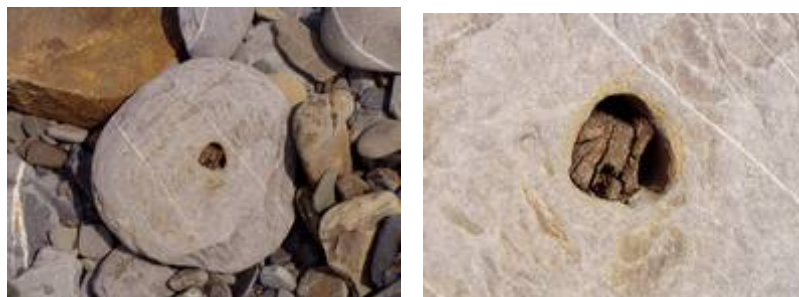
A stone sleeper with its wooden plug still in place.

My next trip to Crickdam at the end of April yielded yet another stone sleeper but this time it still had its wooden plug in place. With the metal detector I managed to locate a lump of metal that had an odd shape to it. After carefully cleaning off the iron oxide crust, it turned out to be the central hole of a cast iron wheel with the stubs of two spokes still attached. The wheel possibly had four spokes, but a close inspection of the wheel centre doesn't seem to reveal there were four spokes. Maybe due to its condition being very barrelled with the action of the sea and stones I can't see the remains of the other two spokes.

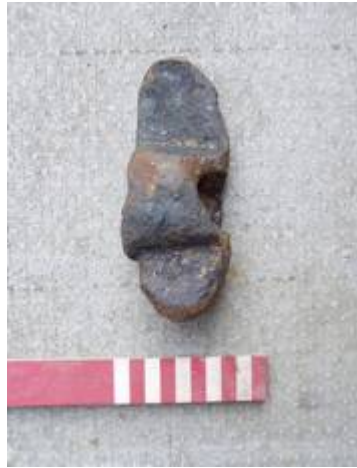
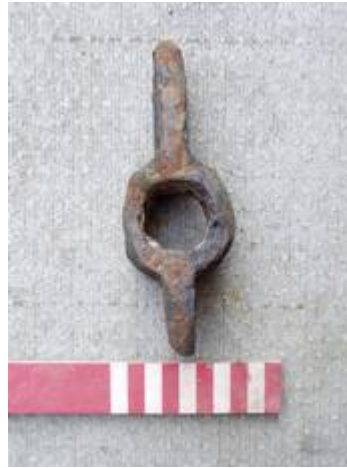
The cast iron wheel centre after cleaning.

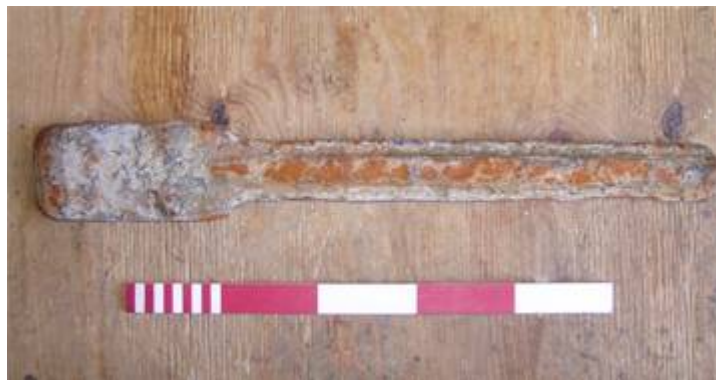
Cast iron sleeper.

Needing to spend some time with the metal detector at Crickdam after the winter storms we had had was imperative. I managed to get out on the Saturday 20th and spend a few hours on a bright sunny but windy afternoon at Crickdam. The stones and shingle had shifted quite a bit since the previous year and I noticed areas that I had previously found artefacts had completely been cleared of shingle down to bare bedrock. I went back over the areas I had done the year before and was not disappointed when one of the signals from the metal detector turned out to be three quarters of a sleeper. There were a few more pieces of the centre sections of sleepers that came up. I have found two different sizes of the centre rail section; one seems to be a bigger more robust casting. Having found only pieces I cannot say yet if there are

two different gauges of sleeper. I need to find more bits of sleeper with the ends attached before I can say for definite.

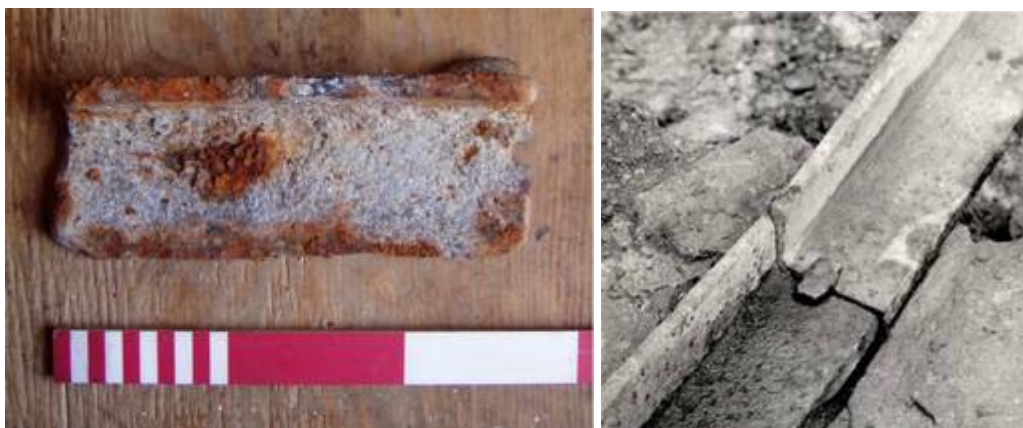
New discovery Plateway with square end and fixing pin slot. Shown in place in right picture.

A new Plateway type came up and it is one of the missing links to the stone sleepers with a single hole in. This is the first piece of 3-inch Plateway with a square end and fixing pin slot in the end I have found. This proves that this type of Plateway was fitted to some of the stone sleepers with a single hole in.

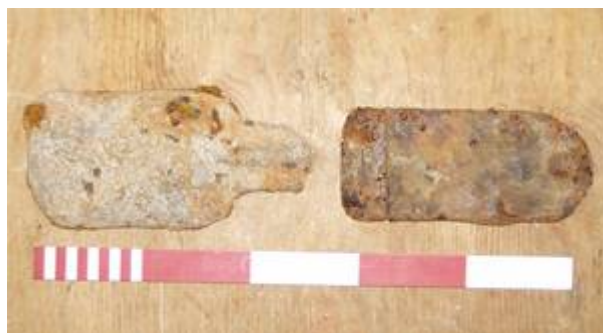
New size of cast iron sleeper end on the left.

This cast iron sleeper end fits the 3½-inch Plateway and I have three and a half lengths of this size of Plateway and only have one complete piece of the 3-inch Plateway. More pieces of the larger size has survived I expect due to having being strengthened underneath with a rib running the whole length and being slightly thicker on each end than the 3-inch Plateway which is the same thickness along the whole length.

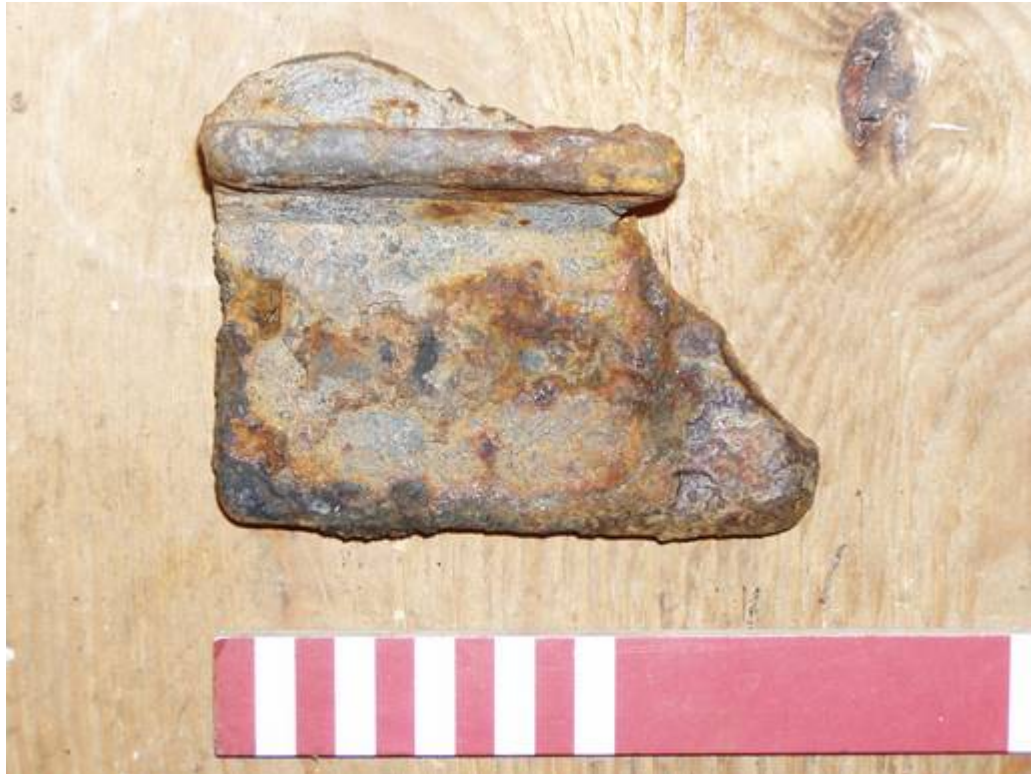
3-inch Plateway with fixing pin slot and larger side seating flange (at the top of the picture).

Also I had found the square end of a piece of 3-inch Plateway, with fixing pin slot that had a slightly different size of seating flange to help the Plateway sit on the stone sleeper without it tipping over.

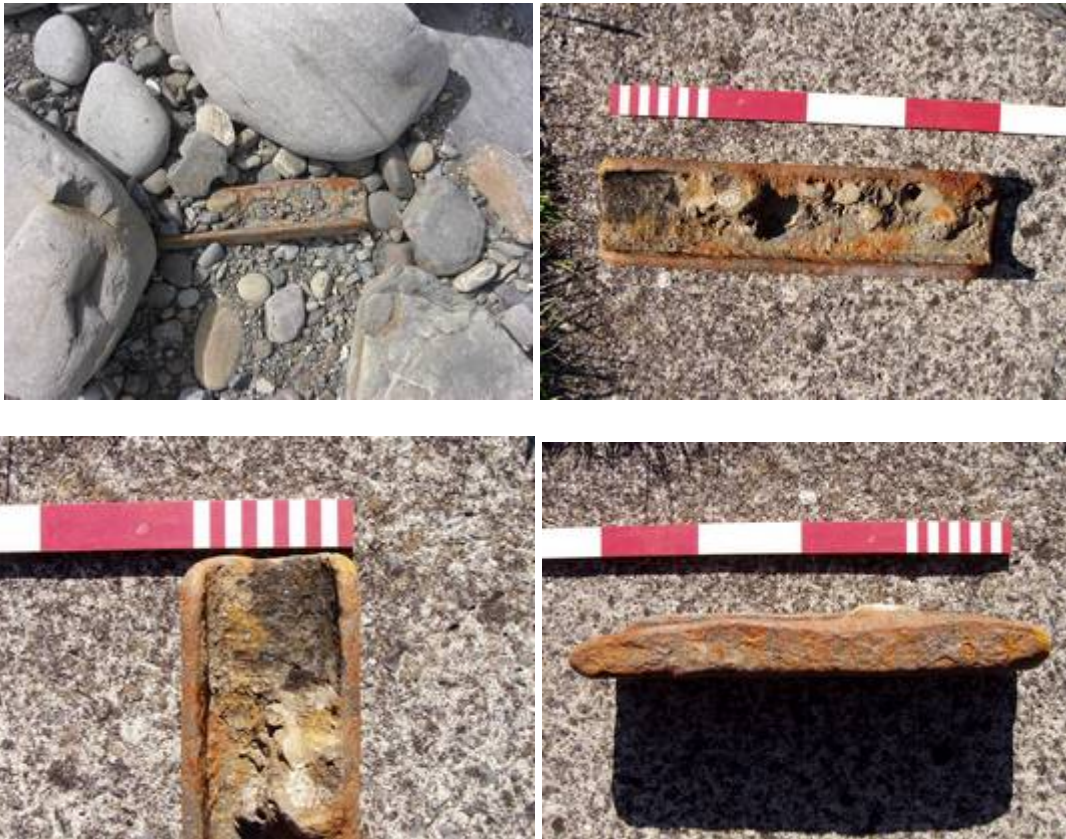
Possible U channel track.
Found 8 June 2008

Storms in the first weeks of June disturbed the shingle and stones at Crickdam to the extent that cast iron was visible amongst the rocks. Two pieces of cast iron were noticeably different from pieces I had found before. On the 8th June having only a few minutes to search around as I was with my family I came across a length of U shaped cast iron. The dimensions are very similar to the Plateway and from the concretion of coal dust and pebbles along one edge of the U channel, points to the possibility of it being another type of Plateway track, with the clear side being where the wheel would run.

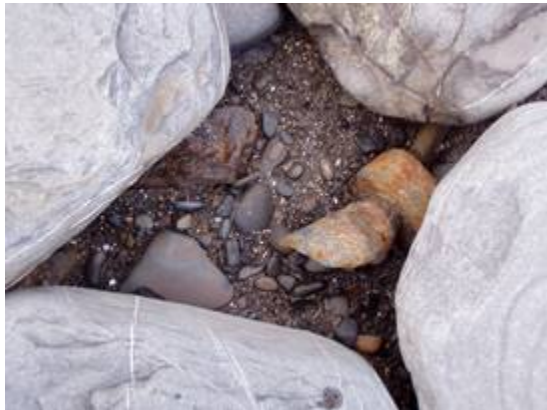
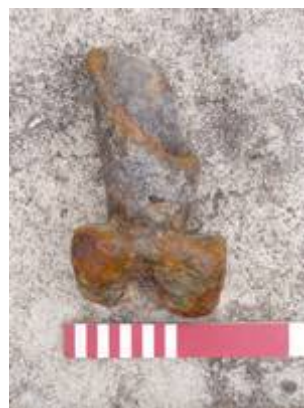
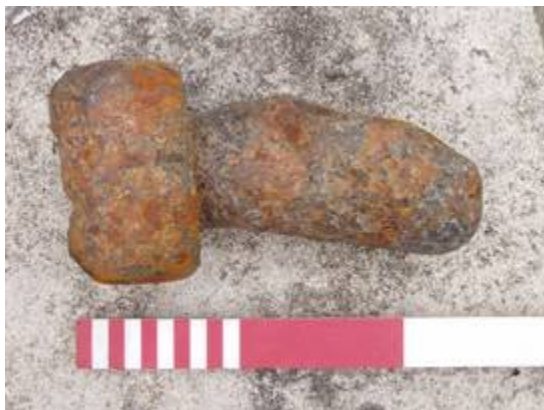
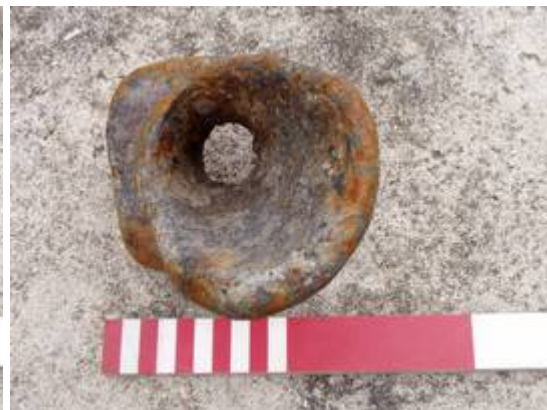
Found 30th June 2008

Unidentified cast iron object.

Identified as a Tuyere from a blacksmiths forge.

A blacksmiths forge works on the principle that air is blown into the small coals of the hearth to create enough heat to soften iron and on other occasions to melt softer metal in a crucible. The air is usually blown into the hearth by a set of bellows worked either by an apprentice or by the blacksmith himself. The air is blown into the side or back of the hearth low down so that the coals are heated equally through the hearth. A sacrificial item known as a tuyere made of cast iron is built into the stonework or brickwork of the hearth and the nozzle of the bellows fits into the cone of the tuyere. The square section that is built into the hearth is usually quite thick, as it has to endure constant heat for fairly long periods of time. Modern tuyeres are water-cooled.

I have at last found physical evidence that there was a blacksmith's forge at Crickdam.

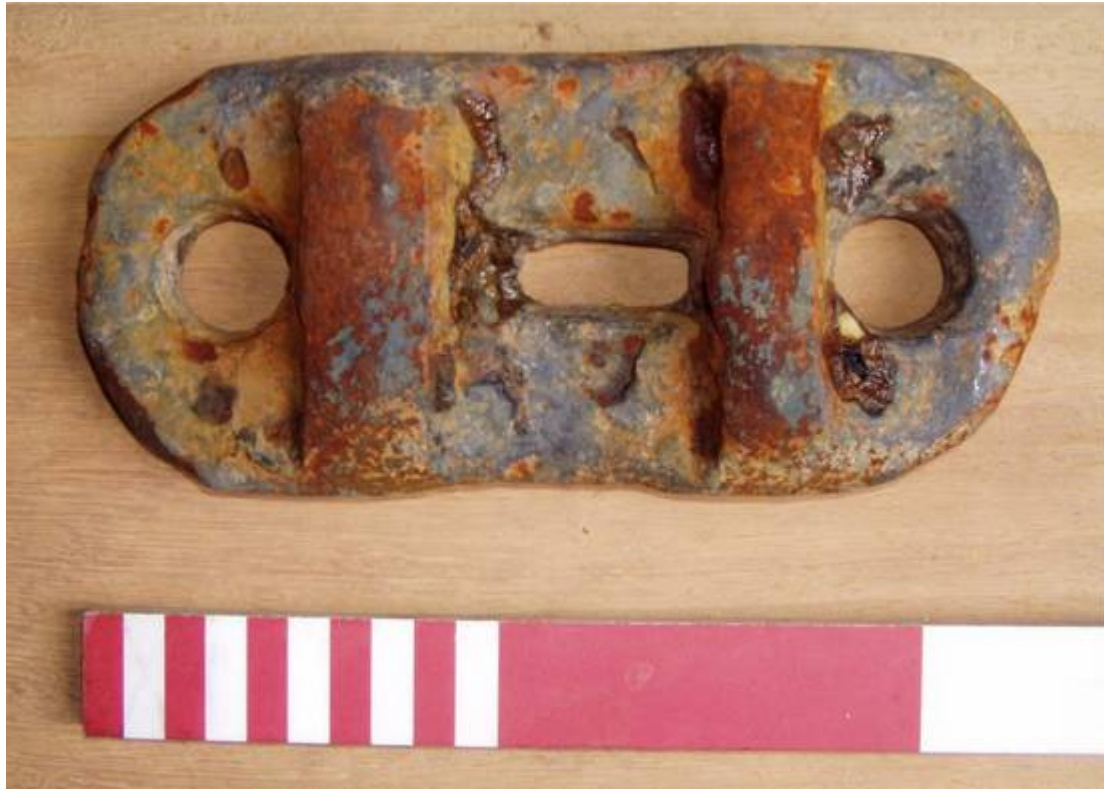
This chair doesn't fit any of the Plateway found so far.

I have to search through the Crickdam collection of Plateway to see if there is anything that matches the chair.

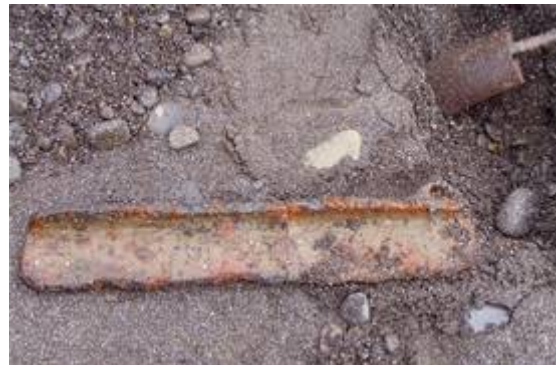
Plateway with a side flange with a hole in.

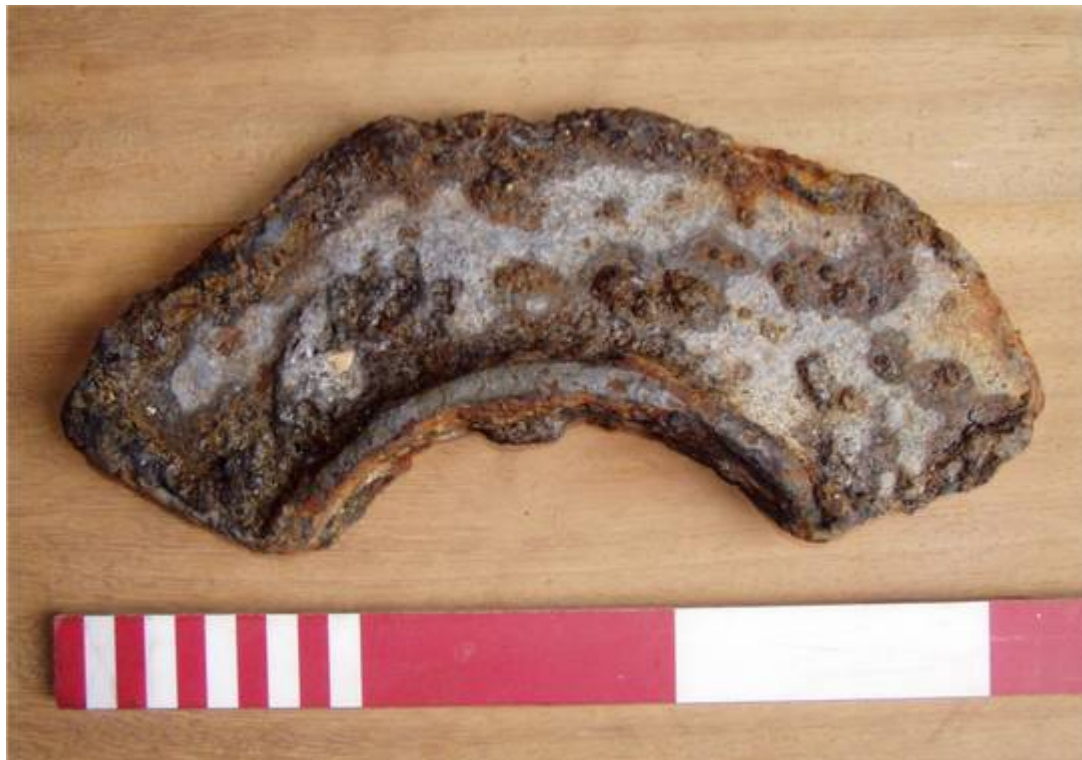
After cleaning there seems to be a broken spoke on the inner curve.

may be a fragment of a wheel. There seems to be a broken spoke on the inner face of the curve. Some early dram wheels were very flat and had different shaped centres for the axel. There are no bolt holes on the flange so I don't think it is the end of a steam or water pipe. A little more research is needed on this piece before coming to a conclusion of what it is.

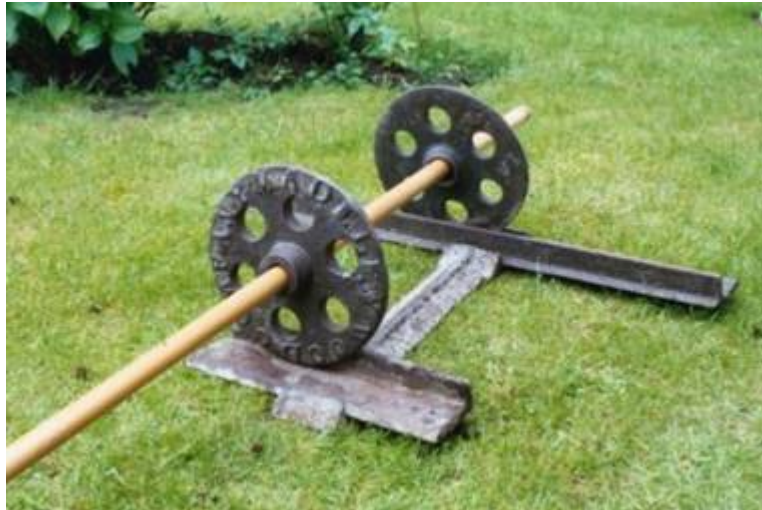
An example of flat Plateway dram wheels.

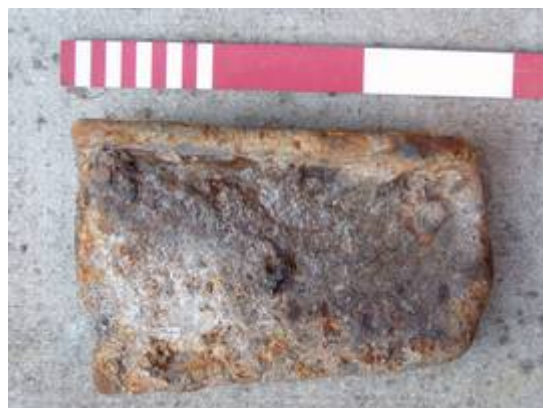
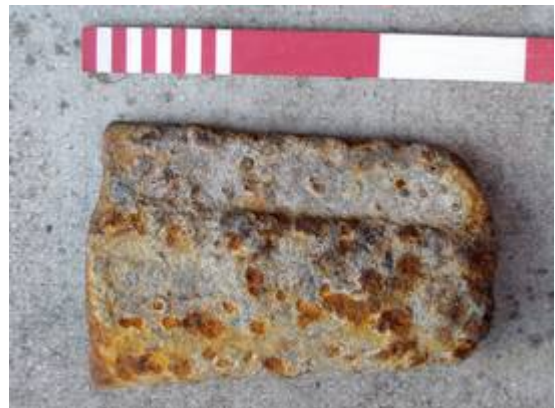
This is either part of Plateway points or where the drams are pushed onto the Plateway.

recorded, sections of the two known types of cast iron sleepers and various wrought iron pieces including a chisel. The one piece of Plateway, which was new to me, was the last piece to be found. I think this piece is part of a set of points or part of where the drams are loaded onto the Plateway.

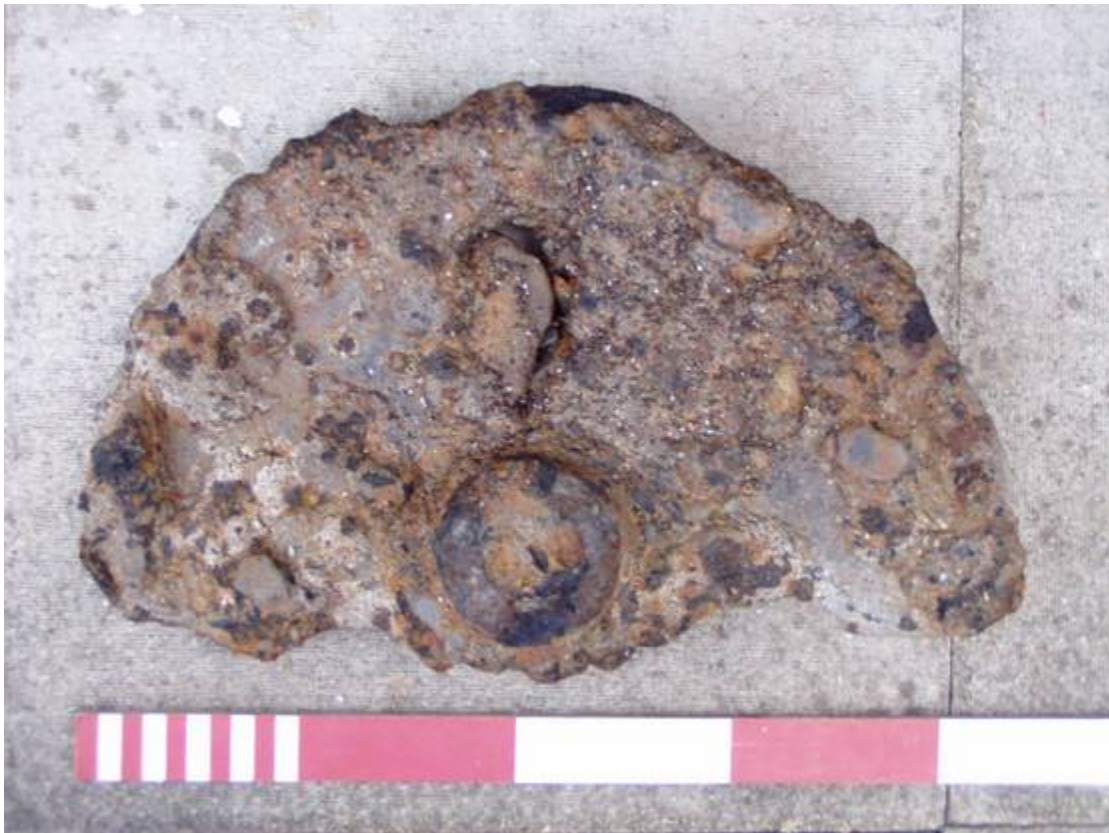
The wheel measures approximately 18 inches in diameter (450mm).

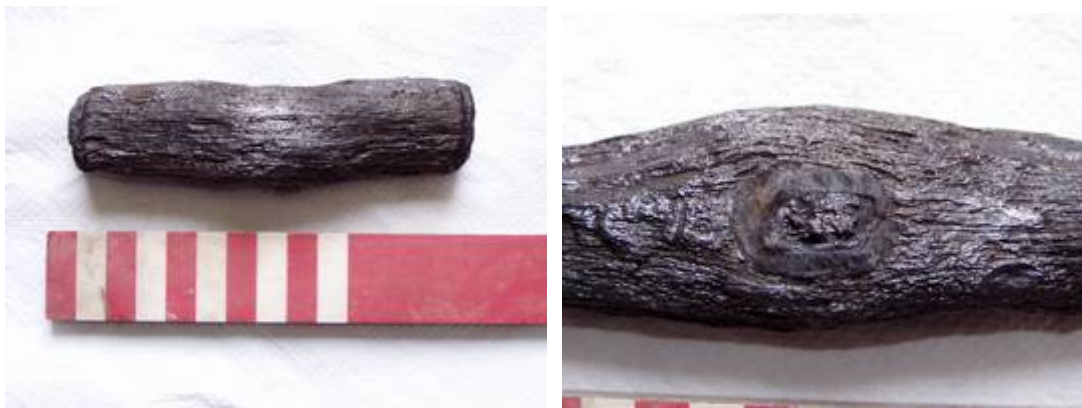
The wrought iron hammer head after electrolysis and drying, and before being treated with tannic acid and coated in red lead and metal paint to prevent air getting to the metal.

Iron conservation is the biggest problem I have. Once the artefacts have been taken out of their marine environment the pieces of cast iron and wrought iron begin to bleed iron chloride. This is mainly due to the constant soaking in salt water, the salt slowly absorbs into the crystalline structure of the cast iron and into the fibrous structure of the wrought iron. Then when the artefact is exposed to air the salt absorbs water vapour out of the air and the metal surface starts to ooze droplets of iron chloride. Wrought iron is the metal that suffers the most as its fibres begin to delaminate due to the oxidation within the metal itself and it literally blows apart. Cast iron due to its crystalline structure fairs a little better but tends to blow pieces off the surface as the oxidation occurs within small cracks of the artefact.

I have tried to keep the relative humidity low in the storage of these artefacts to minimise deterioration and have slowed the process down slightly by using air-drying apparatus. A relative humidity of 15% being the best to completely slow corrosion down is virtually impossible to the layman and can only be achieved in museum conservation laboratories. But to get it down to 20% would be the ideal. I have also been experimenting with electrolysis with the wrought iron artefacts with some degree of success, but still have a long way to go in perfecting this solution with the lack of time and funding being the main problems.

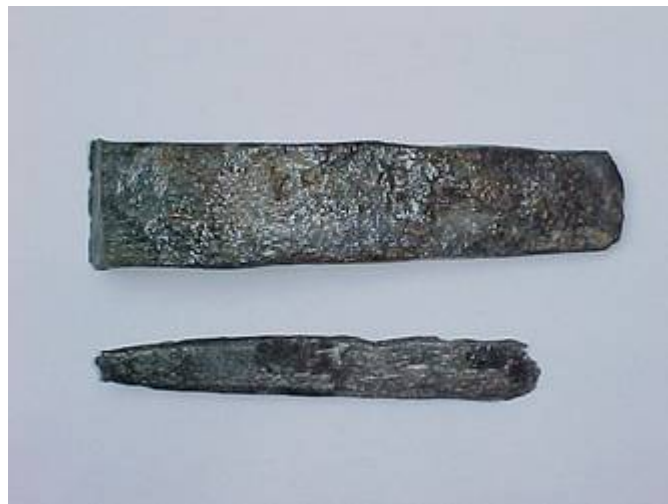
Lacquering also prevents air getting to the artefact after electrolysis.
